DIAGNOSIS AND RESTORATION OF FOUR EXCEPTIONAL EIFFEL-TYPE RAIL VIADUCTS

1. INTRODUCTION AND PROJECT BACKGROUND

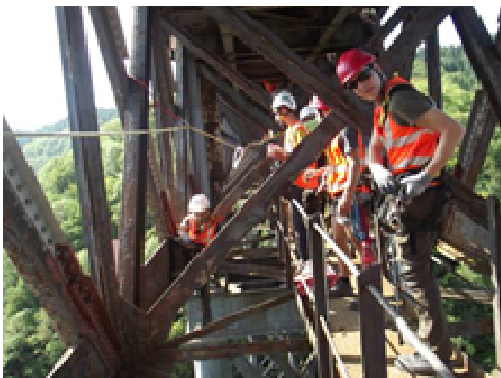
Figure 6: Visit by means of rope access works

- ⇒ *Brief visits carried out by means of rope access works (Fig. 6) and completed at night using hydraulic cradles (Fig. 7) designed to provide up to date information on all the defects which may affect the structures (elements coming apart, splitting, possible cracking, and so on), Taking additional dimensional measurements required for structural models and studies (Fig. 8),*

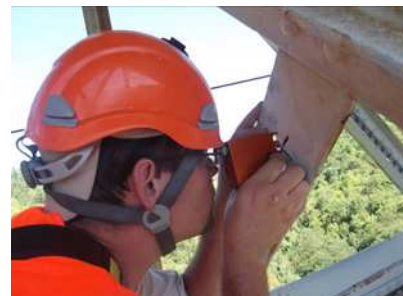
Figure 9 : Anti-corrosion diagnosis

- ⇒ *Carrying out an anti-corrosion diagnosis to reveal the presence of lead oxide in the existing anti-corrosion system (Fig. 9),*
- ⇒ *Researching, by means of spectrophotometry, the tints of the painting that was originally carried out at the request of the Architectes des Bâtiments de France (ABF),*

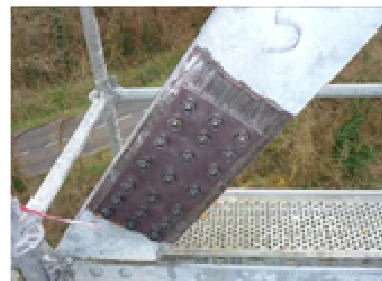
Figure 10: Samples of puddled iron for analysis

- ⇒ *Taking samples and carrying out chemical and mechanical analyses of such samples in order to ensure the accuracy and reliability of the information regarding the materials in situ (Fig. 10),*

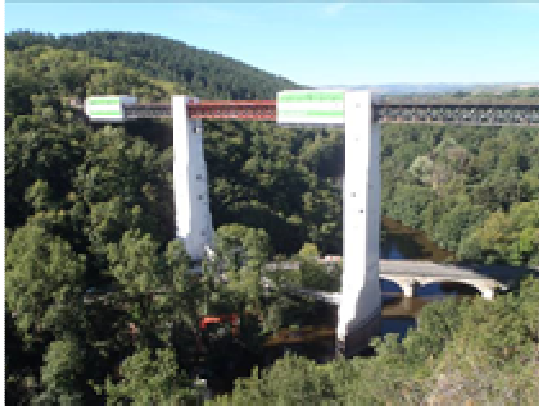
Figure 12: Scaffolding on the Rouzat viaduct

The Rouzat viaduct was in fact the only one to have undergone restoration works and repainting in the second semester of 2013. Lassarat was responsible for these works with an alternative proposal consisting of using two wheeled scaffoldings of 18 ml on the deck alongside the complete confinement of the two piles (Fig. 12). The lost abrasive technique was used.

This study highlighted the need to carry out provisional reinforcements to the bottom brace of the deck (excessive compression and risk of buckling) with pliers and areas of splitting to the shafts of the piles to the right of the rafters (excessive traction in the cast iron). The cast iron piles were partially prestressed by 80 tons by being anchored into the stone by 20 tons per shaft.
