Aix-en-Provence FRANCE May 29 – June 1, 2012

Effects of the concrete damage due to corrosion of steel bars on the static and dynamic response of PRC/RC beams

Prof. Ing. Roberto CAPOZUCCA

UNIVERSITA' POLITECNICA DELLE MARCHE

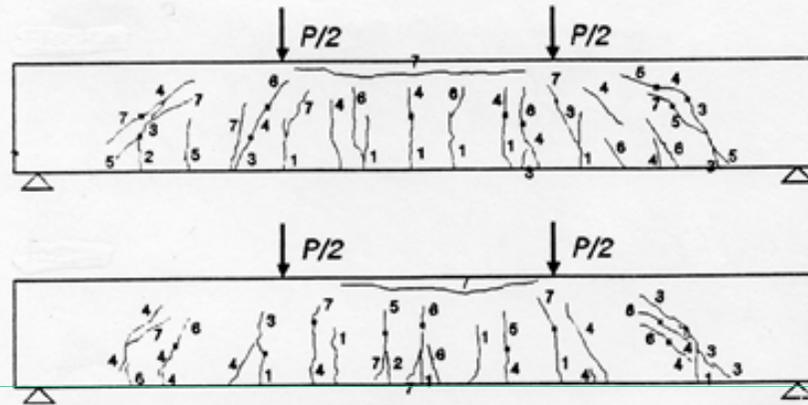
Undamaged RC Beam under bending tests

PIL 8: quadro fessurativo. Valgono le stesse convenzioni grafiche utilizzate per il rilievo di PIL 1. Per i carichi di inizio ricognizione si ha invece:

Undamaged
RC beam
Concrete
w/c=0.4

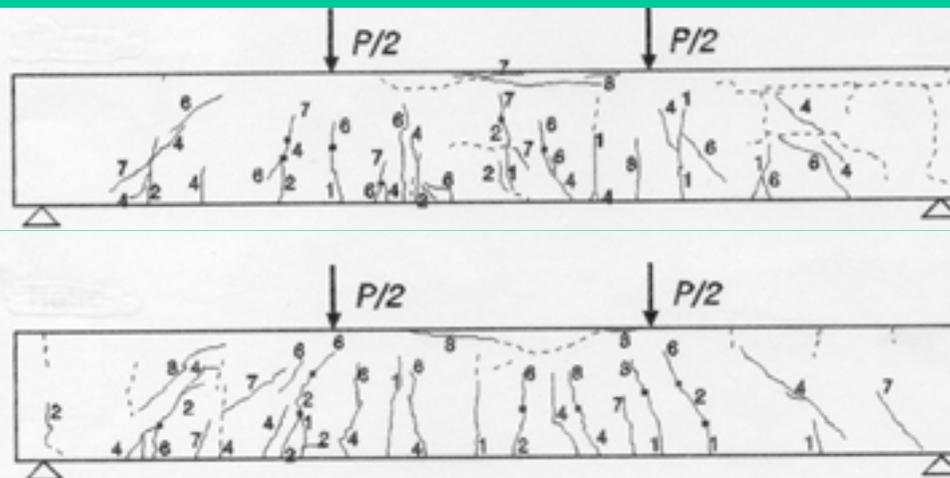
Damaged RC Beam under bending tests

PIL 4: quadro fessurativo. Valgono le stesse convenzioni grafiche utilizzate per il rilievo di PIL 1. Per i carichi di inizio ricognizione si ha invece:

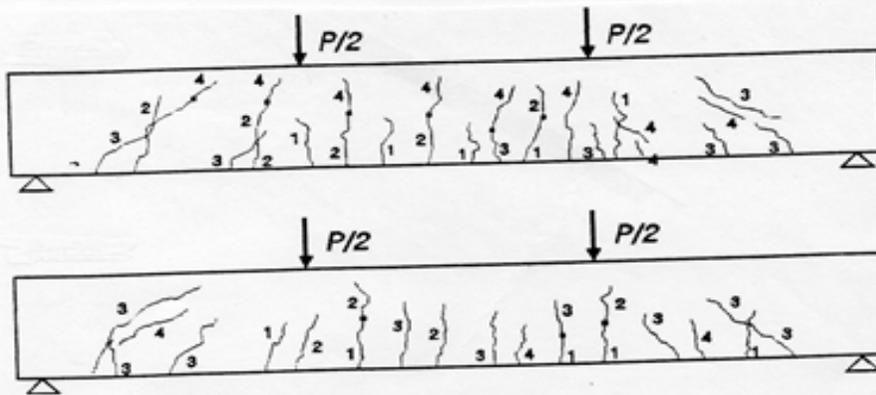
PIL 16: quadro fessurativo. Valgono le stesse convenzioni grafiche utilizzate per il rilievo di PIL 1. Per i carichi di inizio ricognizione si ha invece:

Undamaged
RC beam
Concrete w/c=0.6

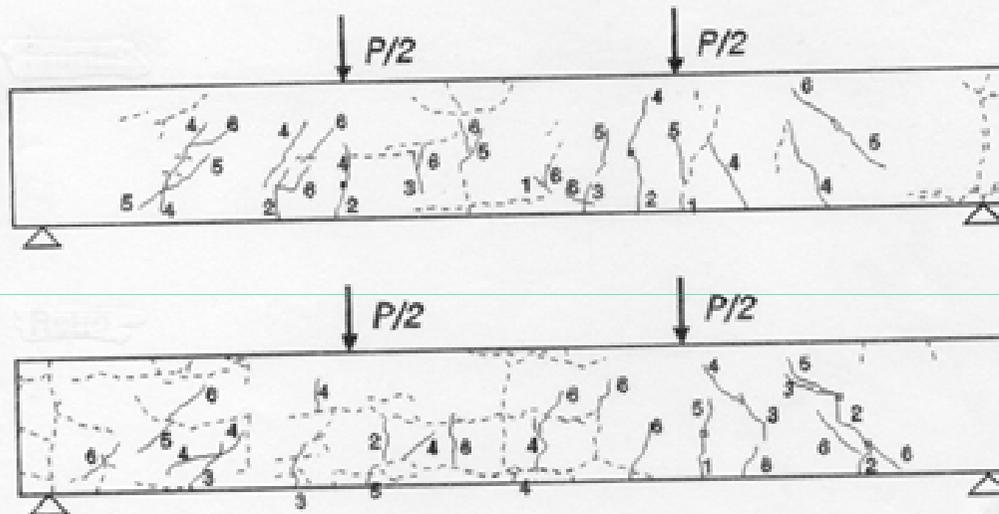
Damaged RC Beam under bending tests

PIL 2: quadro fessurativo. Valgono le stesse convenzioni grafiche utilizzate per il rilievo di PIL 1. Per i carichi di inizio ricognizione si ha invece:

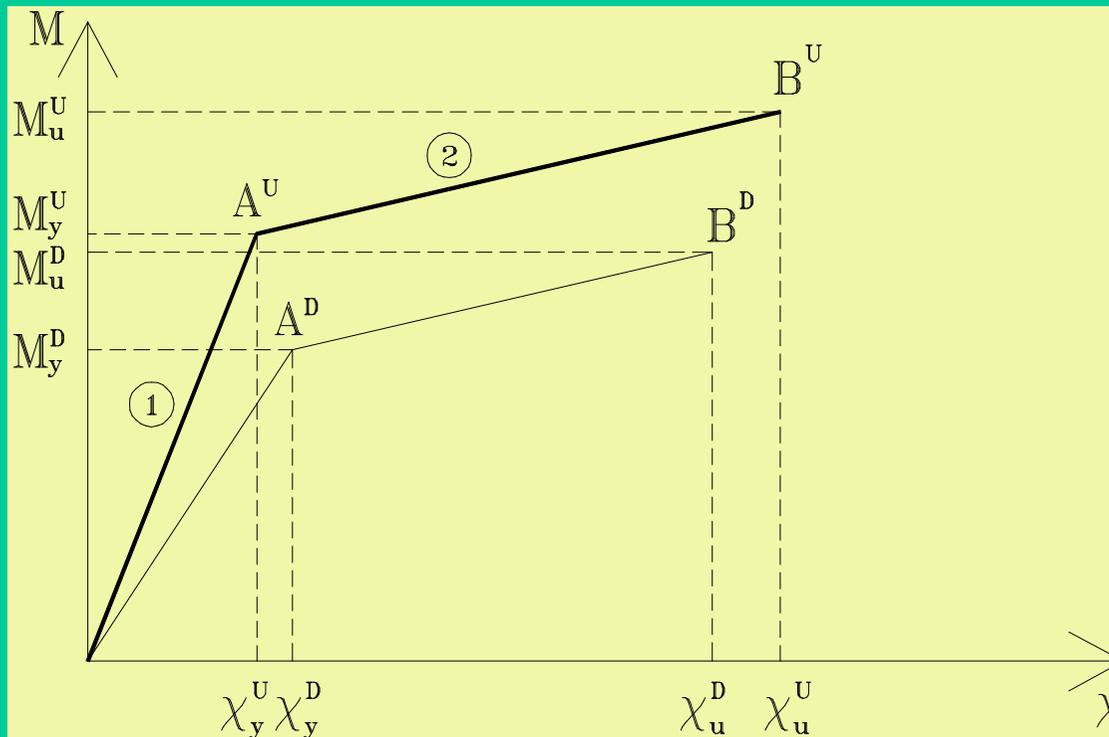
Cracks due to rust create a compressive softening effect in the concrete thus influencing strength, ductility and load-deflection response of the beam.

On the basis of experimental moment-curvature diagrams a coefficient of damage in the elastic field may be defined comparing the response of undamaged (U) and damaged (D) beams by bending stiffness

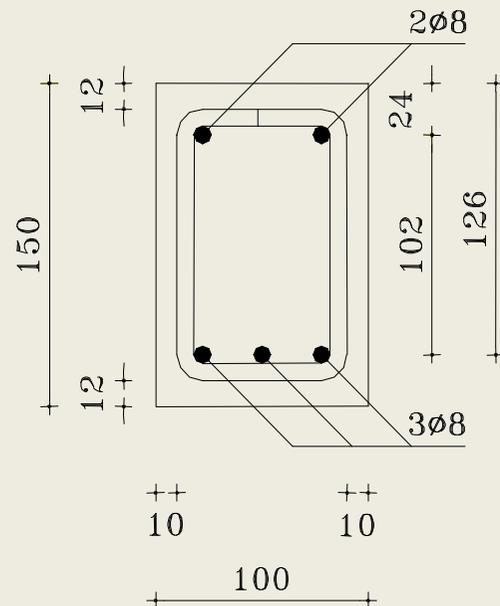
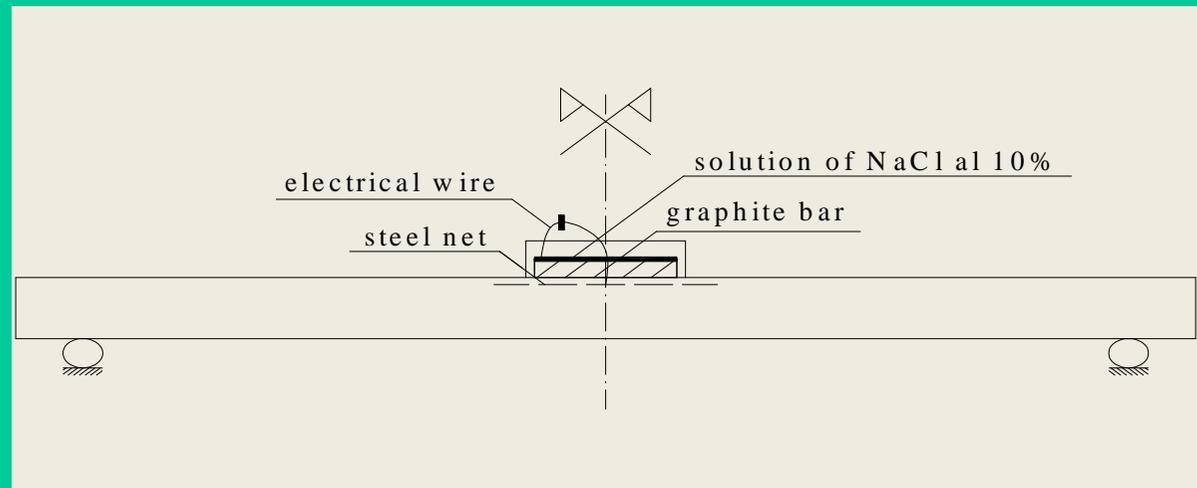
1. Three RC beams (B1, B2 and B3) were experimentally tested.
2. The beams have a rectangular reinforced section with the length $L=2.45\text{m}$.
3. A steel net is positioned in the middle of the beam.
4. Two beams - B2 and B3- have been subjected to cycles of accelerated corrosion through the combined action of a sodium chloride solution (NaCl at 10% of concentration) and a graphite bar electrically joined to the steel reinforcement .

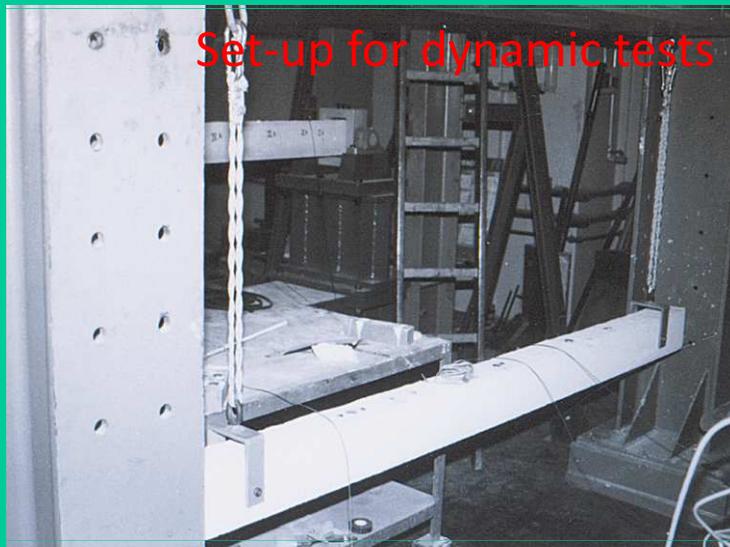
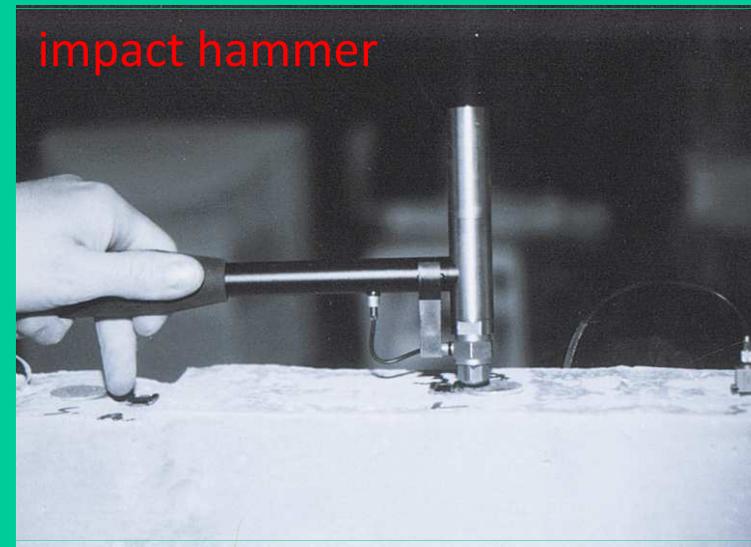
Free vibration frequencies were measured for beam B1, undamaged beam, and B2 and B3, subjected to the corrosion cycles. During the dynamic tests, the beams were hung by flexible springs that simulate the free-free conditions.

The beams were excited by an impulsive load given by an impact hammer, and the response was measured at different positions using accelerometers.

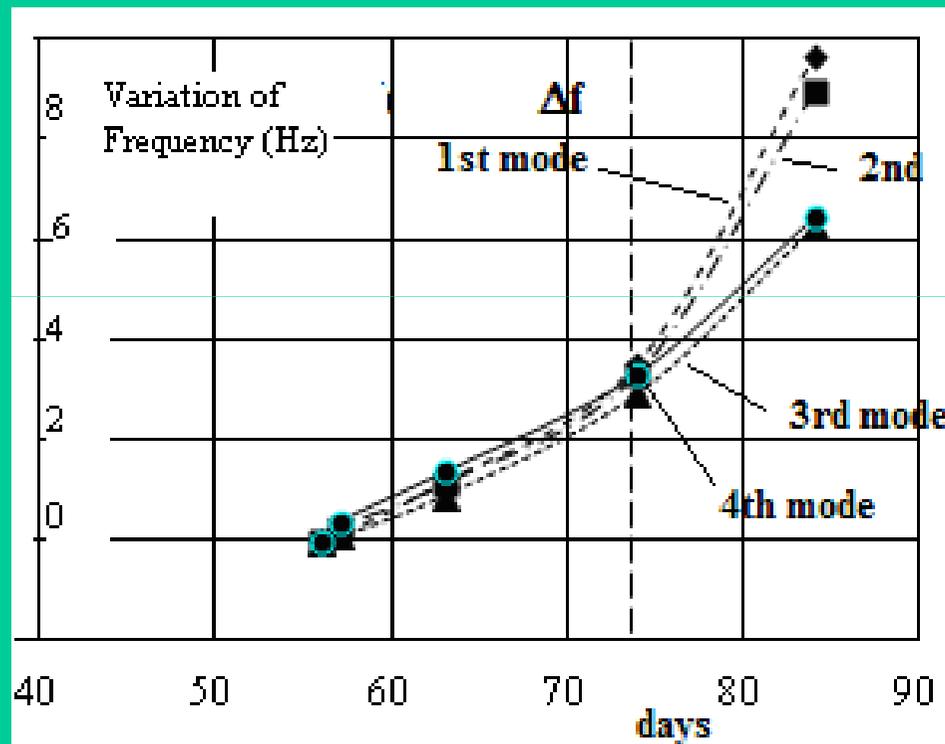
In the Figure the variation of frequency values measured on beam B2 at time is shown.

Variation of exp. frequency values for beam B2 damaged by corrosion.

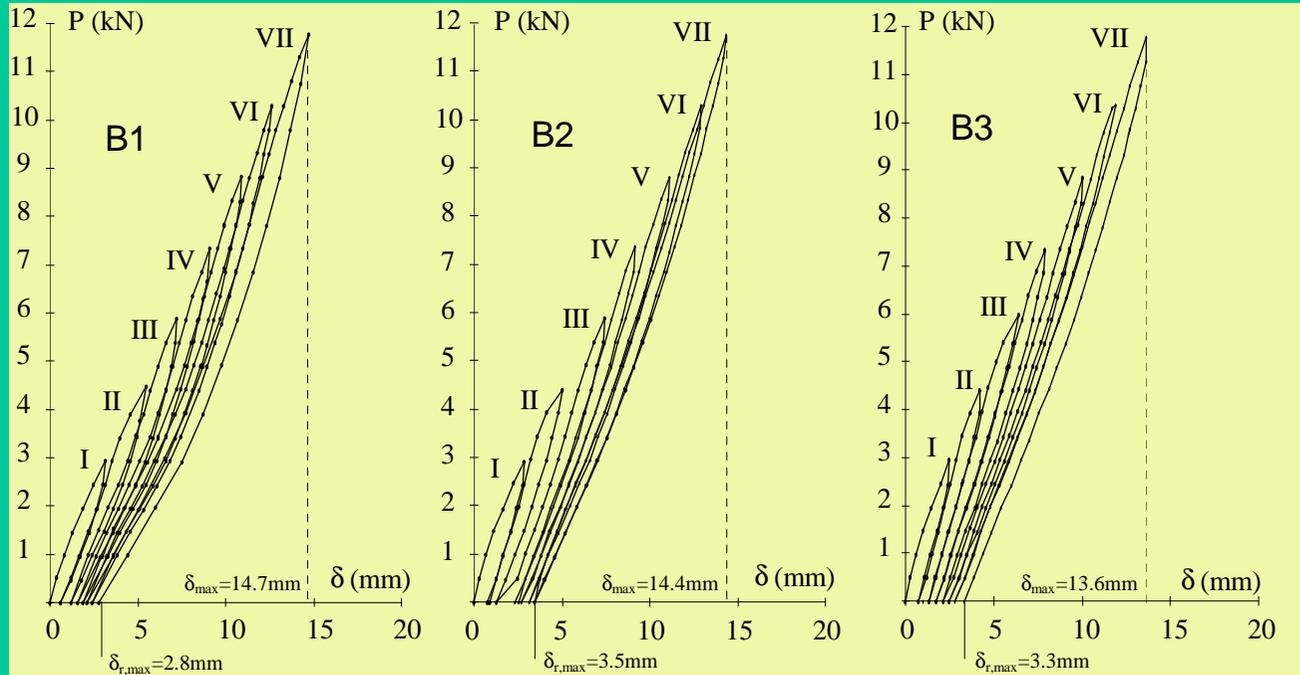
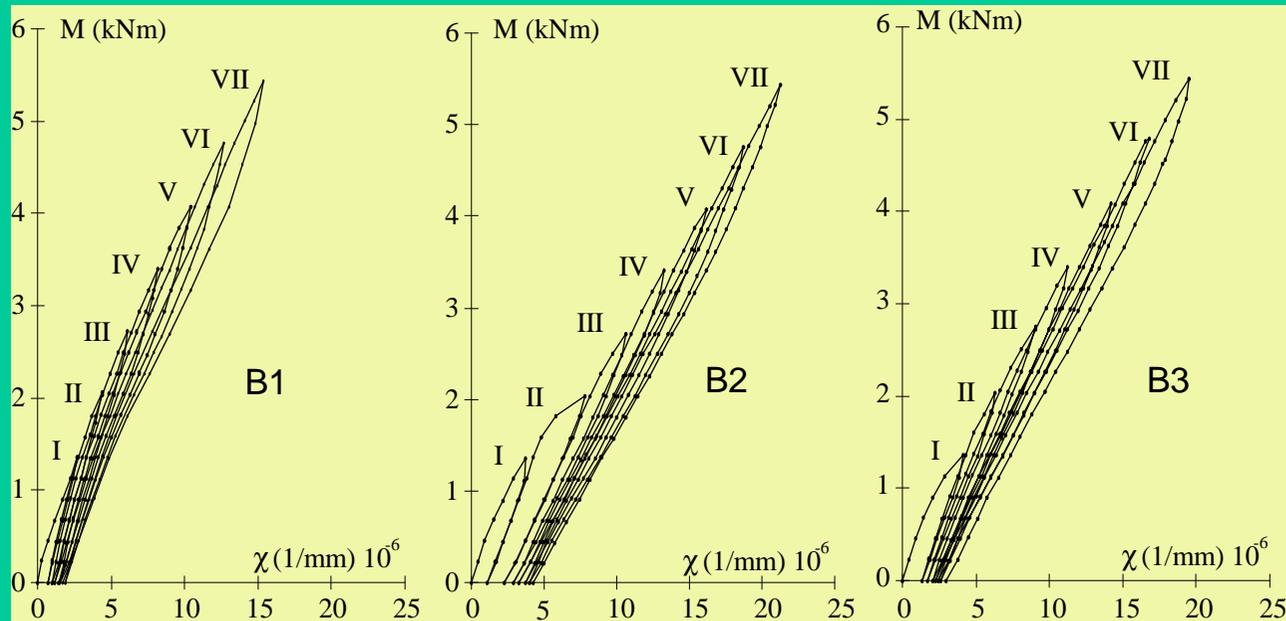
Experimental results from static bending tests on rc beams

The values of curvatures of B2 and B3 are higher than those for undamaged beam B1 .

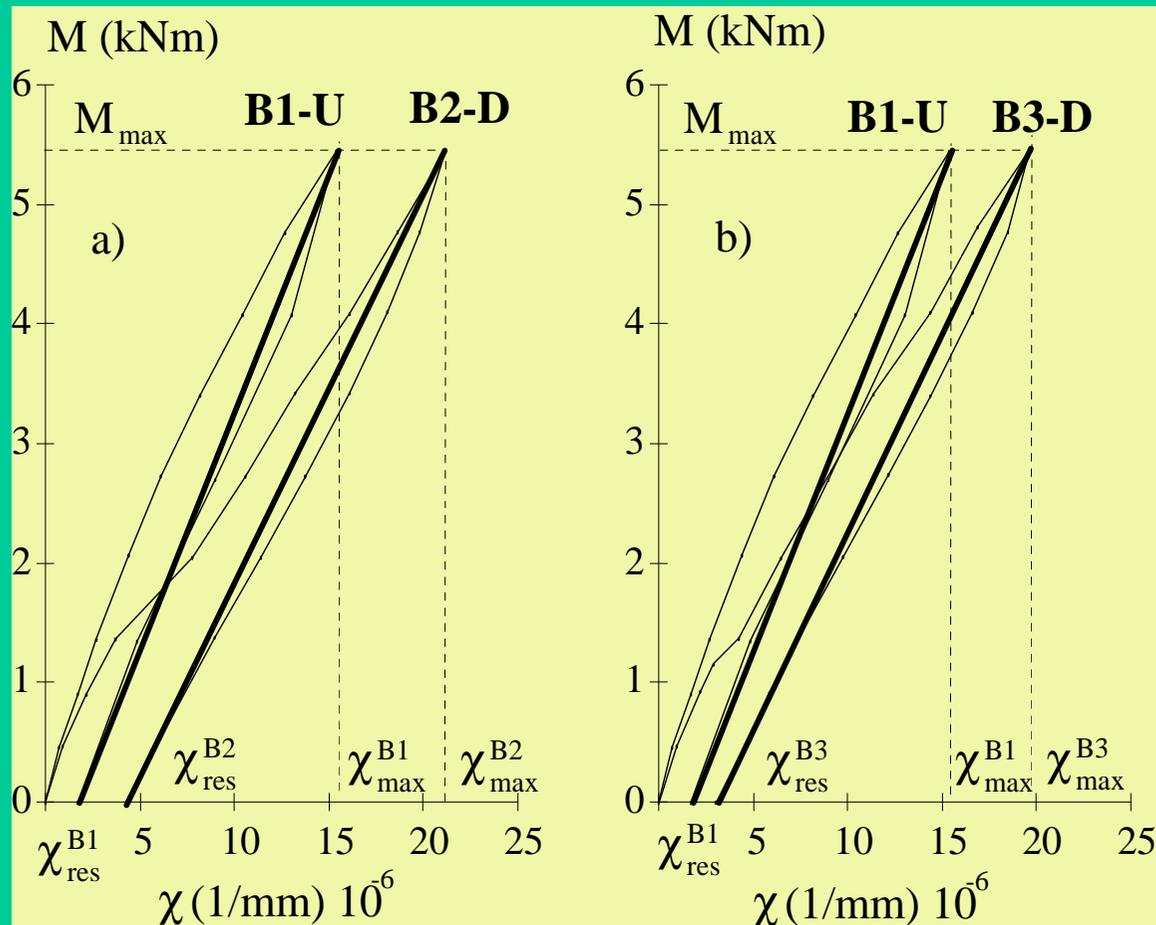
Assuming an ideal straight lines for experimental moment vs curvature diagrams, the coefficient of damage may be evaluated:

DC = 0.20 for beam B2;

DC = 0.18 for beam B3.

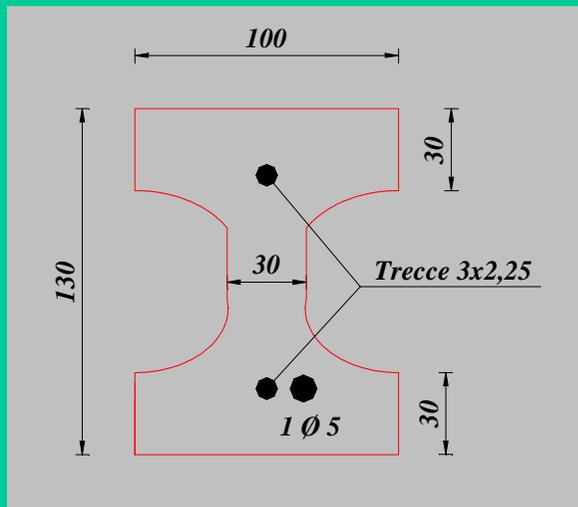
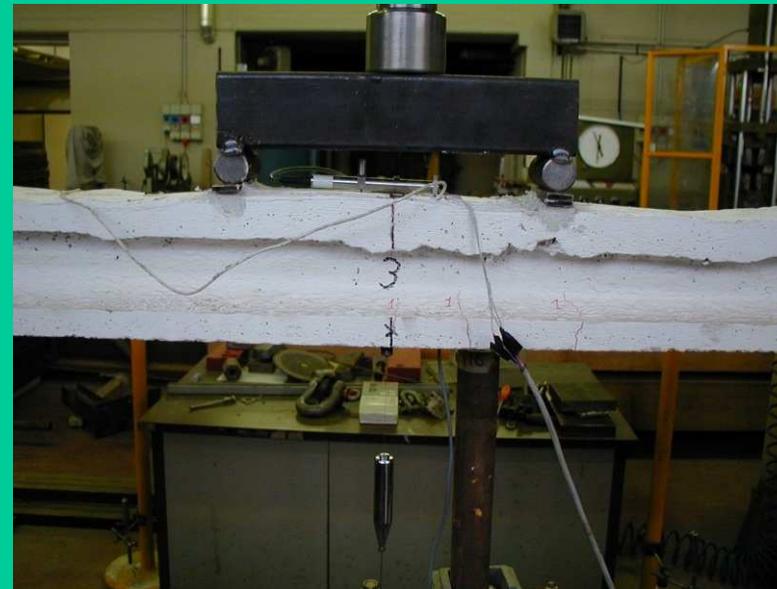
The dimensions of double T section were: 100x130mm, respectively, for base and height; 30mm for width. The length of the beams was 2.45m .

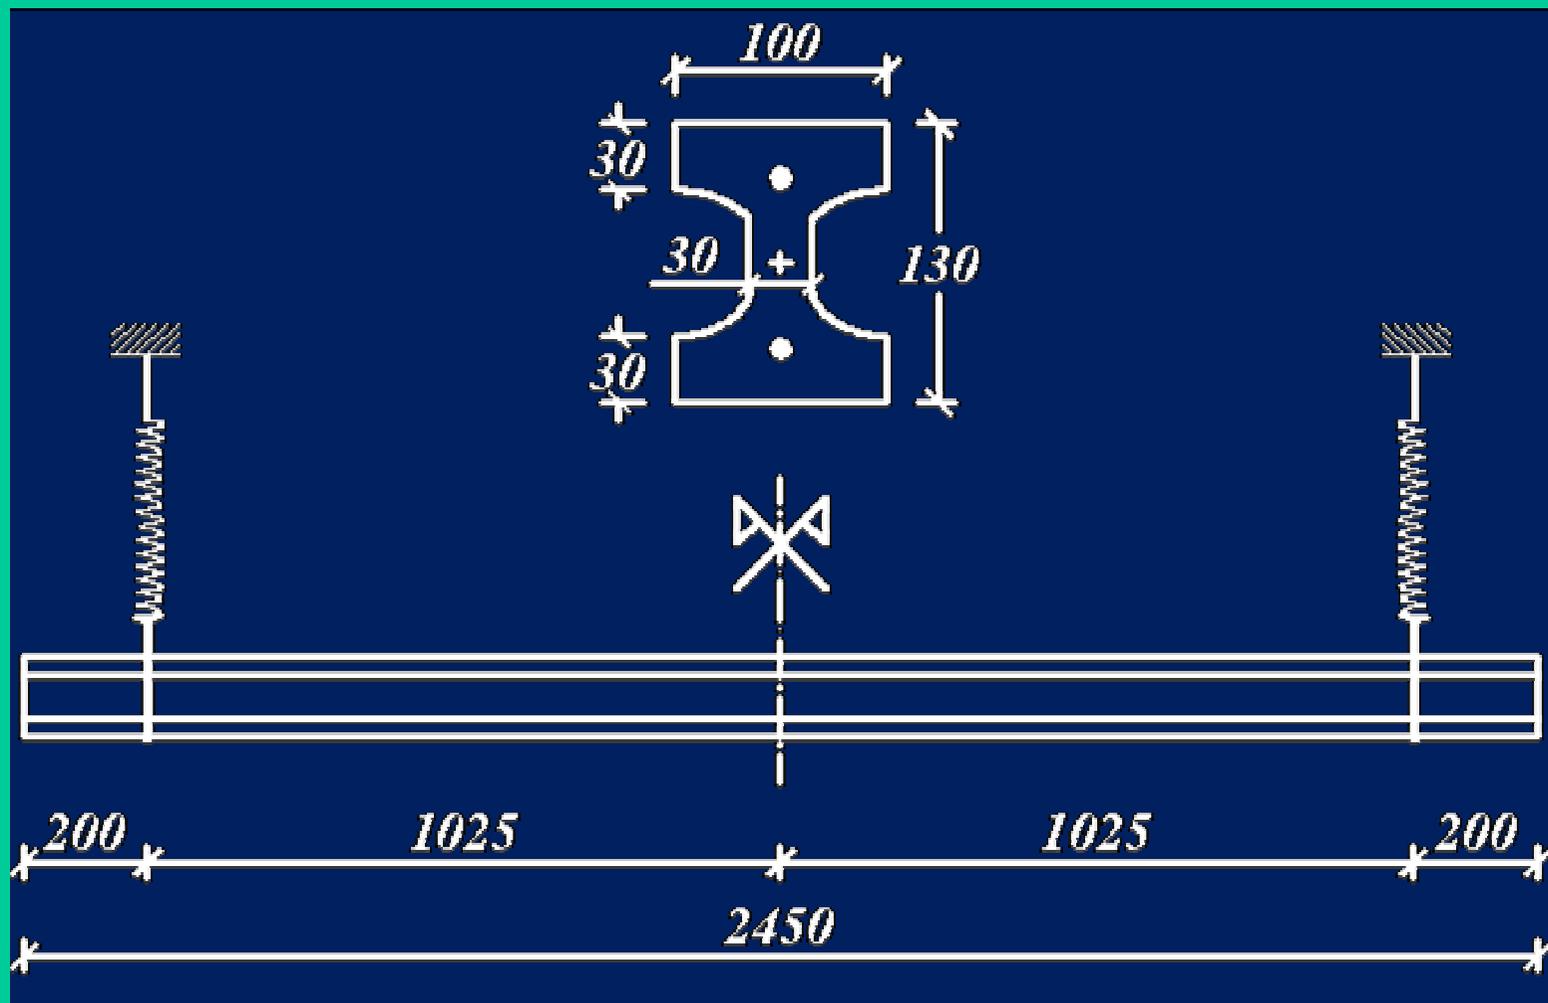
Both beams B1 and B2 were successively tested by bending with the following load path.

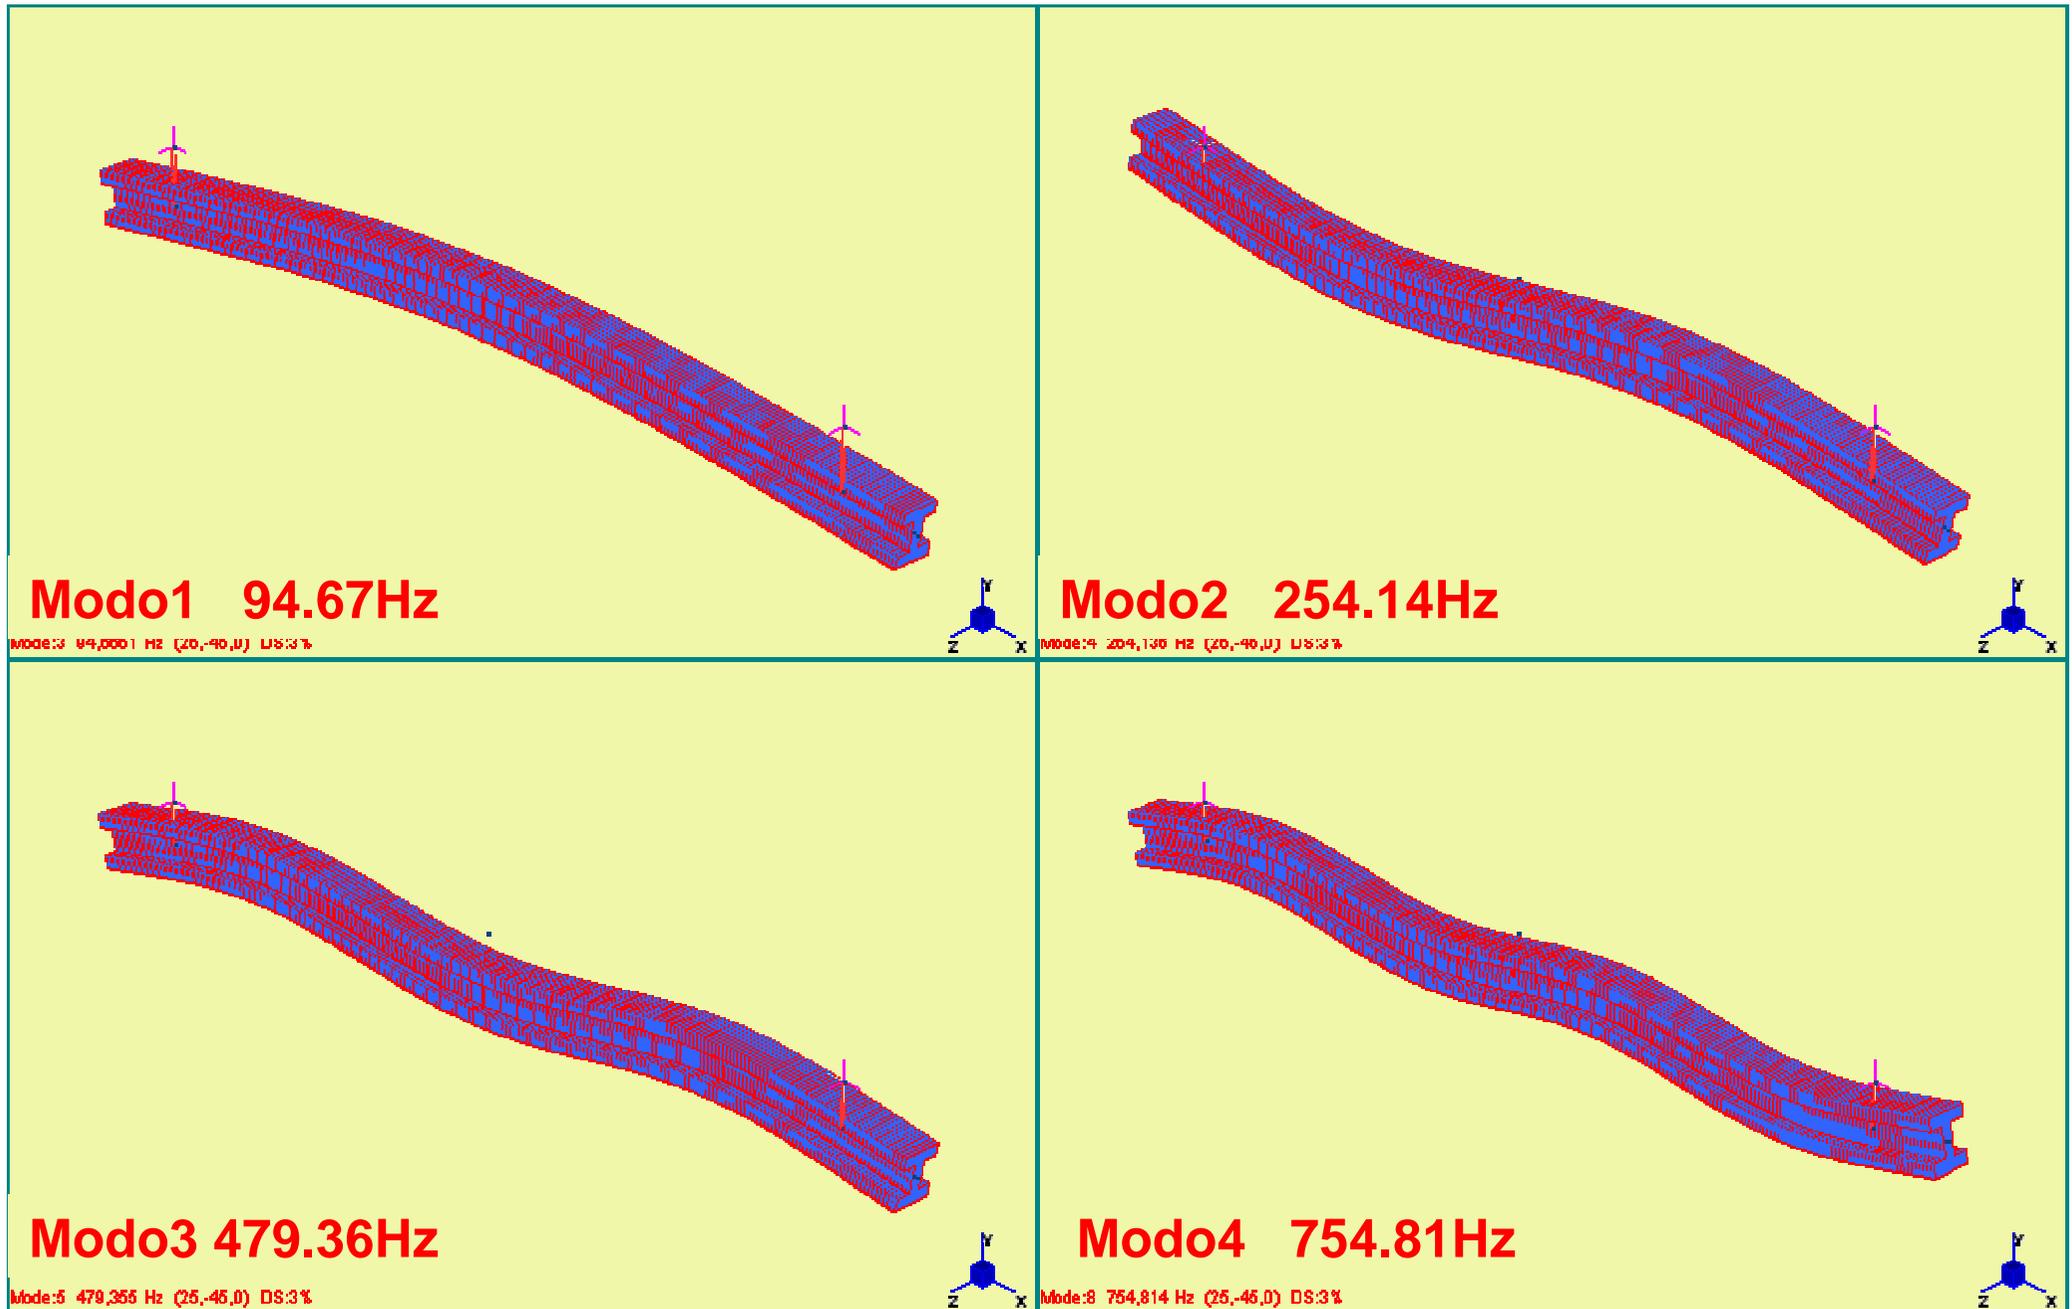
Analysis by FEM

Beam free-free ends

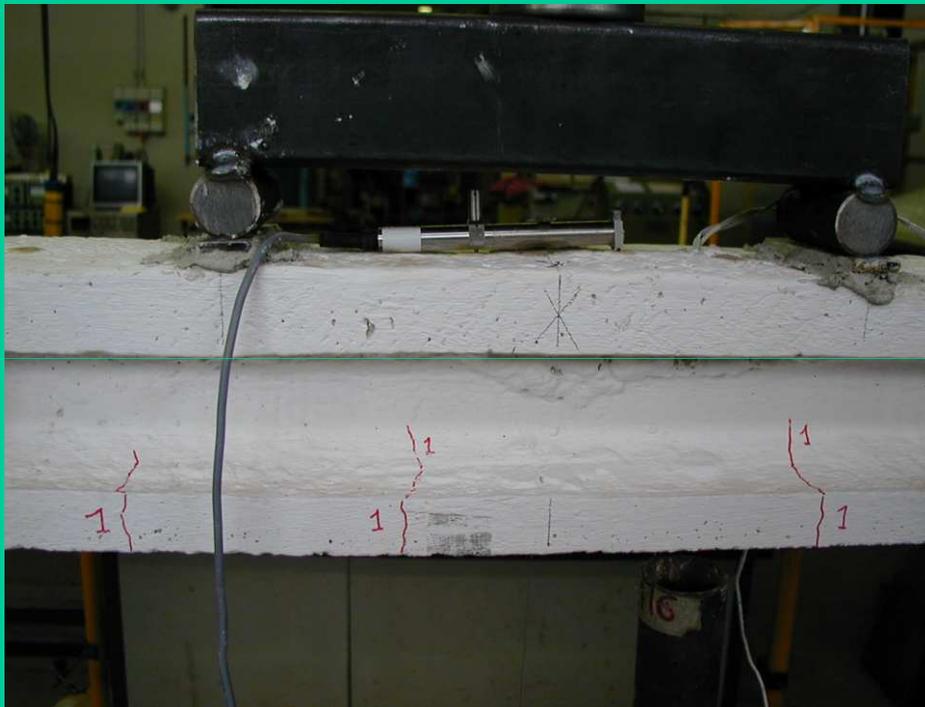
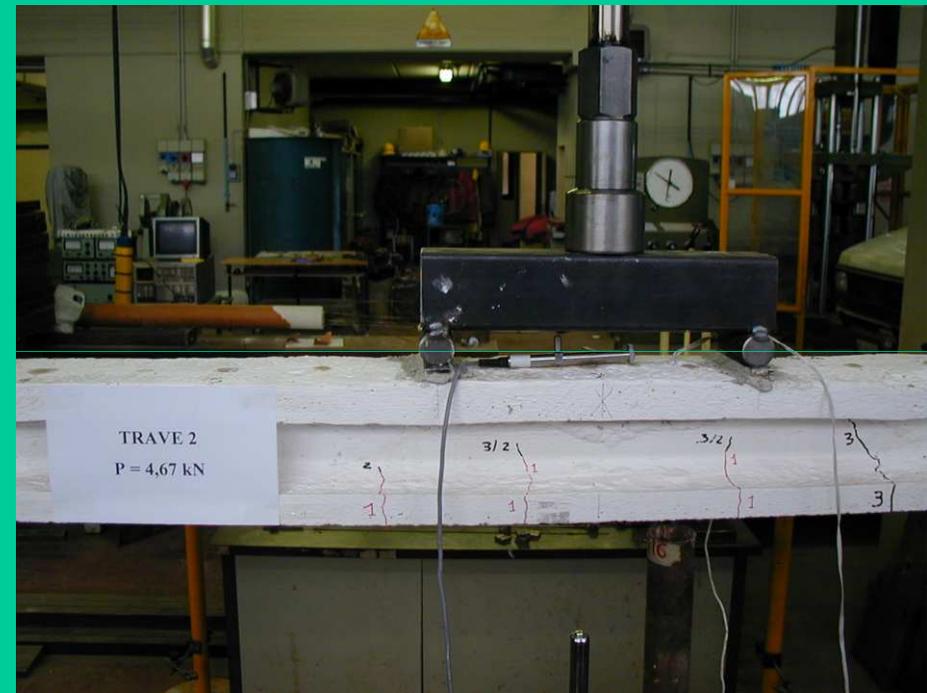
The experimental frequency values obtained by the dynamic tests show a relationship between the corrosion damage in B2 and changes in the frequencies. Although evident phenomena of damage such as cracks on the compressive concrete's surface were not present, the PRC beam, B2, subjected to artificial corrosion process, suffered from a reduction of frequency values greater than the values recorded in beam B1.

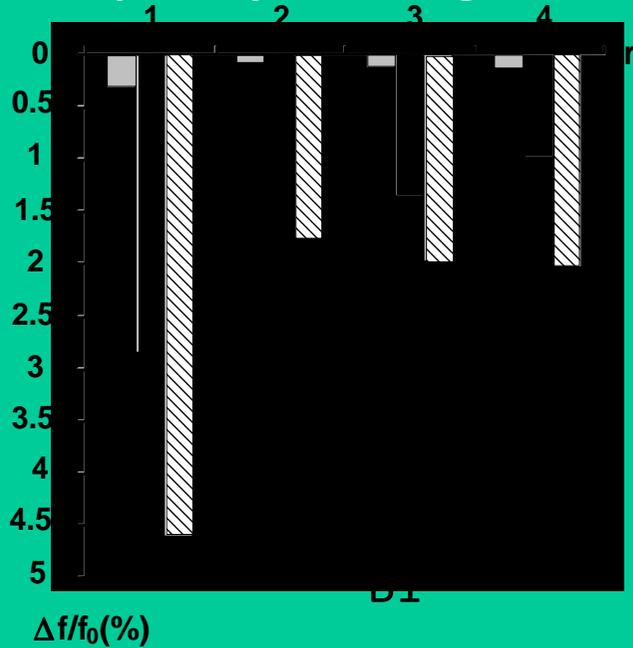
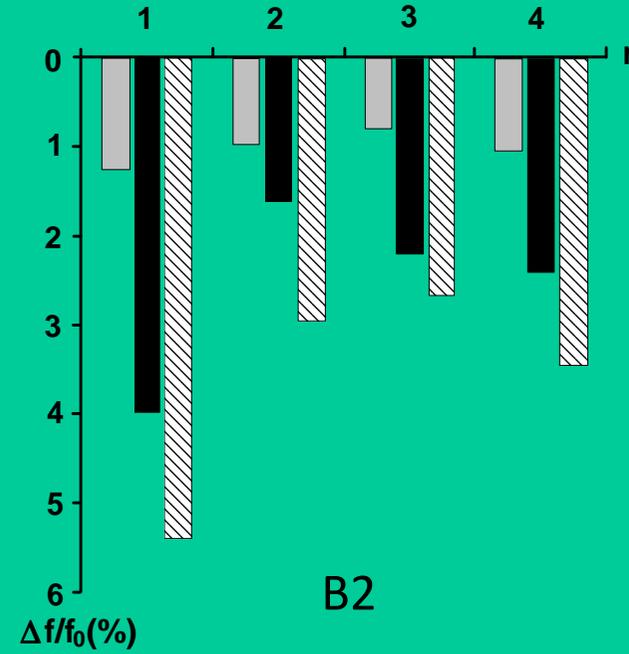
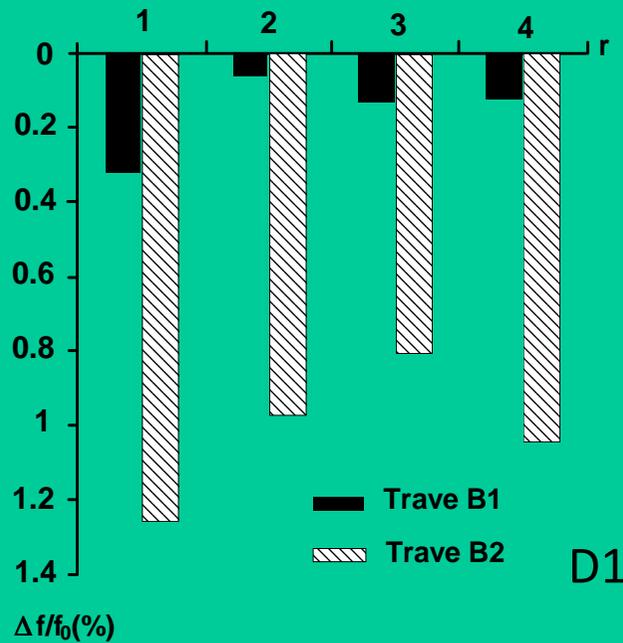
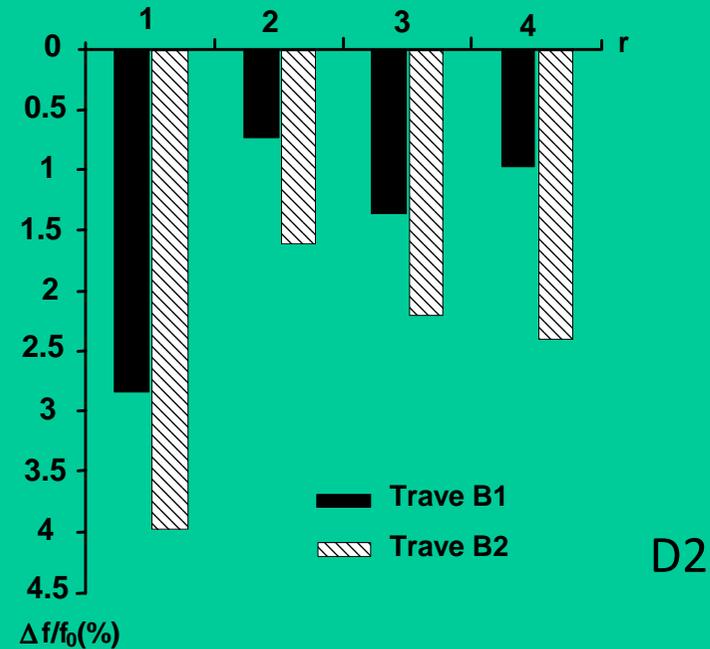
Beam B2, subjected to artificial corrosion process, suffered from a reduction of frequency values greater than the values recorded in beam B1.

Frequency variation values at the different degree of damage (D1-D2-D3) for different modes of vibration

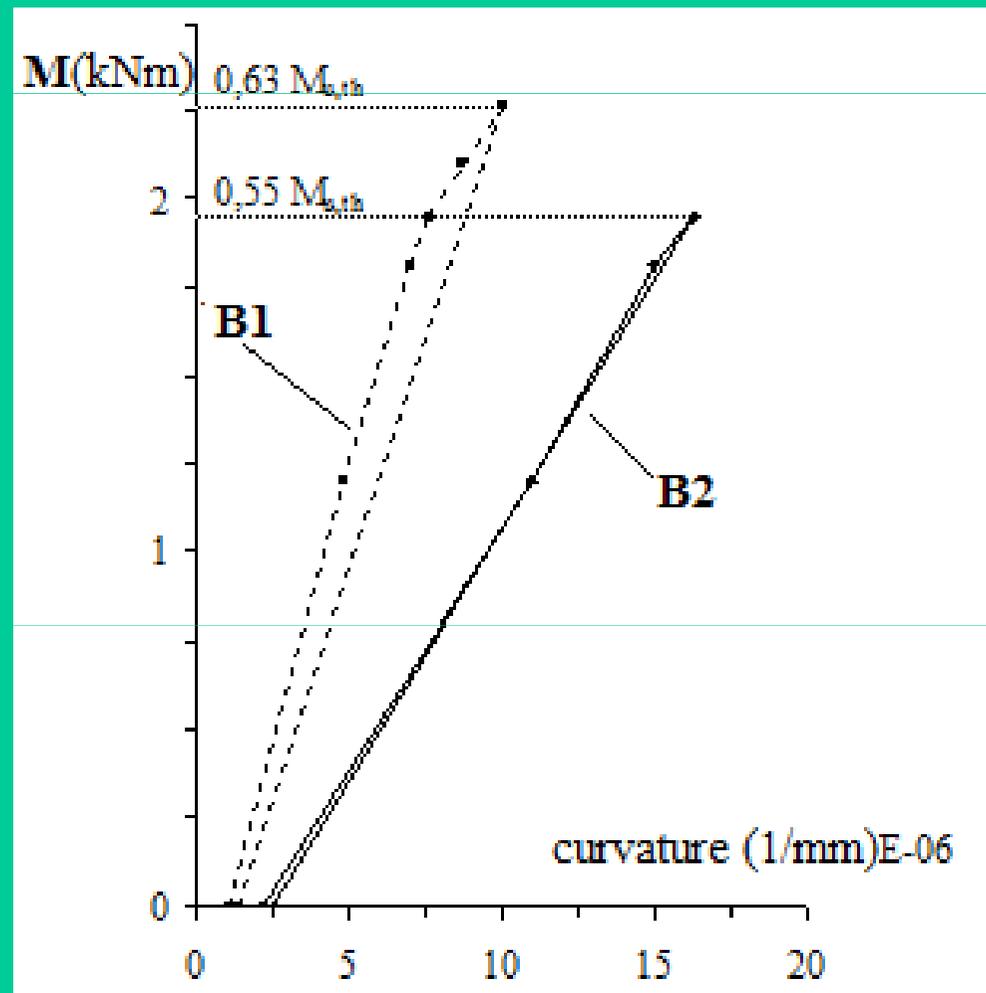
The main effects due to the corrosion process on the reinforcement located in the compressive zone of pre-stressed beam B2, is a loss of stiffness in the experimental moment-curvature diagrams.
