STRENGTHENING OF THE CHASSE-SUR-RHONE OVERPASS ON THE A7N MOTORWAY

Jean-Michel ODIN, Stéphane LAURAND

ARCADIS

FREYSSINET

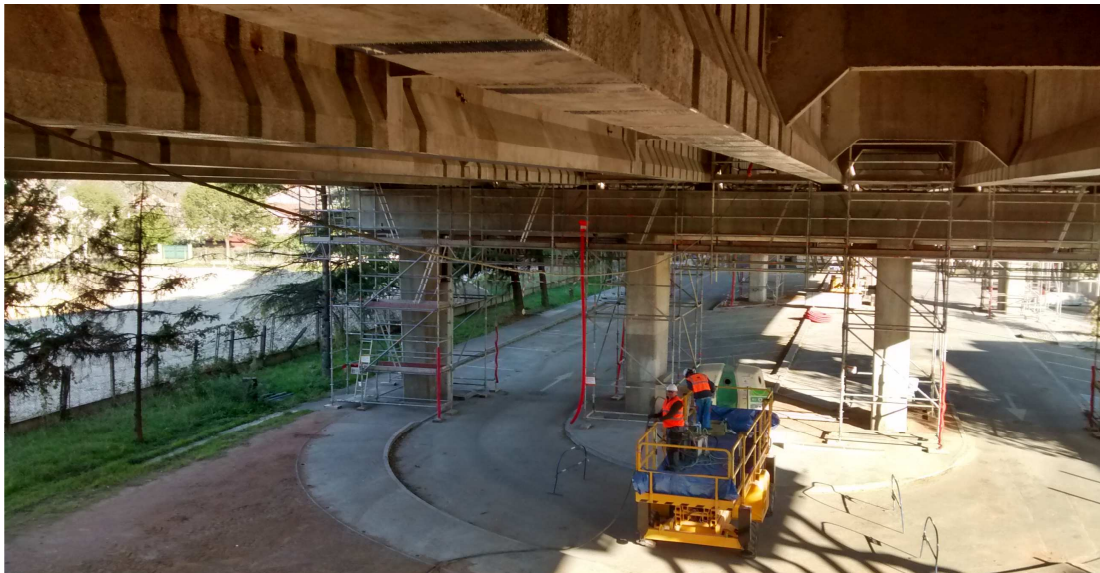
Figure 1: general view

Built in 1963, this 300 m long viaduct comprises nine 33.25 m long simply supported spans. Each span is made of precast post-tensioned « I » beams. This type of deck is referred to in French as a VIPP deck type.

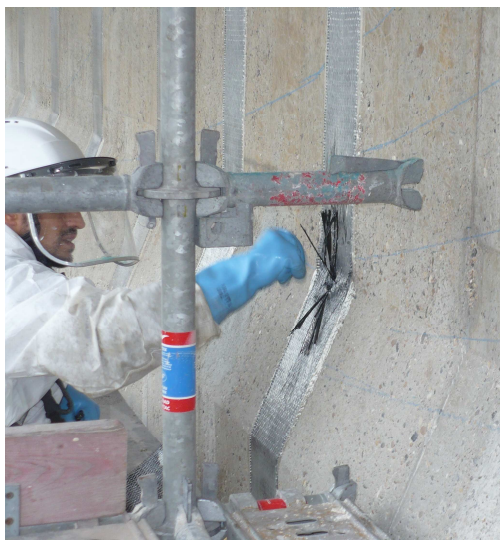
Figure 5: anchoring against pull-out forces in vertical strips.

Strengthening against shear is made of 15 cm wide one layer vertical strips of the same material. These strips go around and under the beams. Anchors are placed wherever pull-out forces may occur. To maintain traffic underneath the bridge, mobile platforms are used (fig 6).

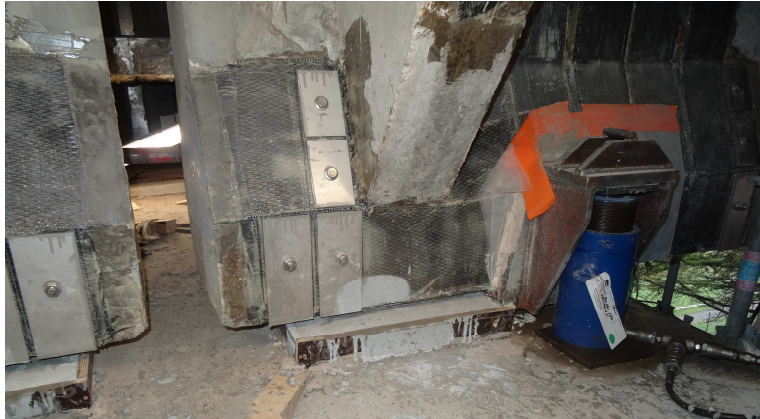
Figure 7: beam extremity: CFRP sheets anchorage with stainless steel plate

At the beams extremities, the shear vertical strengthening is increased to three layers that are anchored with stainless steel plates. This allows to increase the CFRP working tensile stresses from 417 MPa to 789 MPa at ULS.

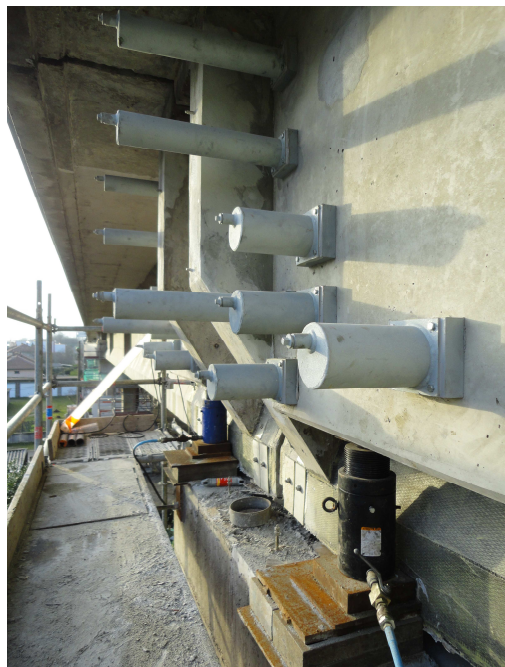
Figure 8: concrete anchorage block at beam extremity

This lead to strengthen end diaphragms with 3 monostrand external cables of the T15S type. The effect of this post-tensioning was analysed with a full span 3D finite elements model. Site measurements have shown that the structure is more flexible than expected, which is favourable.

Monostrand cables are anchored into cast in situ blocks that are also used for jacking. These blocks are connected to the existing structure by prestressing bars Freyssibar Ø 36 mm.

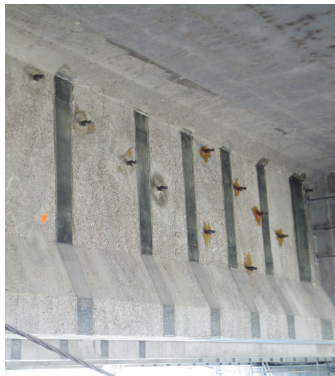
Figure 11 : injectors along the cables layout

- Sealing of injectors located every 0.50 m,
- Airtightness testing by blowing compressed air from each injector individually,
- Airtightness testing from one injector to another in order to characterize the filling state of the sheaths,
- Implementation of the transducer,
- Injecting the corrosion inhibitor at a pressure of approximately 4 bars in polluted zones,
- Monitoring the impregnation of the inhibitor (progression, duration and volume),
- Micro grout re-injection through the same injectors,
- Removing injectors and plugging holes.

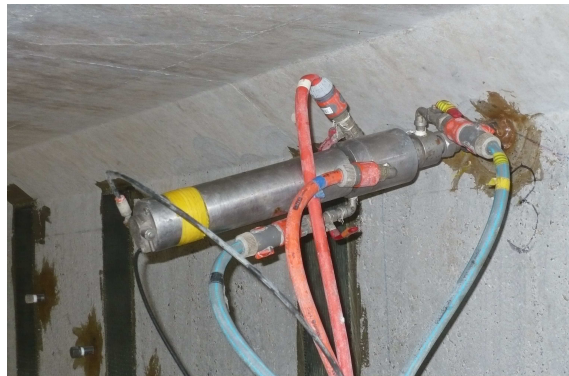
Figure 12 : corrosion inhibitor ultrasonic transducer

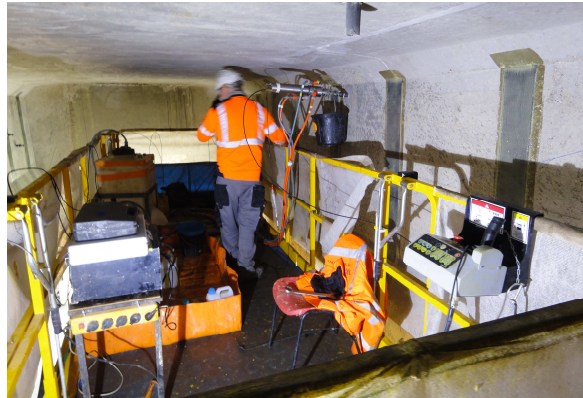
Figure 13: corrosion inhibitor impregnation workstation on platform

Impregnation is considered sufficient when the inhibiting solution percolates at the adjacent injectors which act as vents. Impregnation duration varies from 30 min to 2 h, depending upon cement grout filling of the ducts. Polluted anchor heads are systematically impregnated over a period of 2 hours.
