LARGE-SCALE STRENGTH TESTING OF HEXCRETE SEGMENT DESIGNED WITH UHPC FOR TALL WIND TURBINE TOWERS

Robert Peggar (1) and Sri Sritharan (1)

(1) Iowa State University, Ames IA

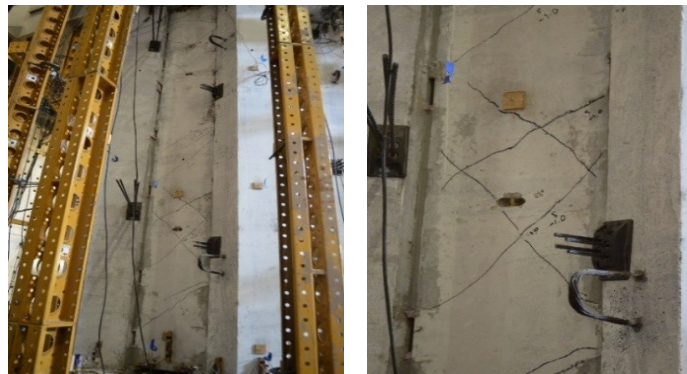
Figure 5: Cracking of the two HSC connecting panels after completion of operational torsional loading

moderate amounts of cracking as shown in (Figure 5) while only a single crack appeared in the third HSC panel. These cracks, which were marked with a black marker for visibility, did not exceed a width of 0.1 mm (0.004 in). No further damage was observed under operational loads. The cracks also completely closed upon unloading of the test unit.

As previously stated, the HSC panels were not designed to crack under operational torsional loads. After further investigation of the data collected from the panel instrumentation, it was determined that the construction sequence and use of smaller radial tendons were both responsible for the observed cracking. The vertical post-tensioning introduced a larger amount of precompression in the panels than was predicted before the test and this precompression was not present in the connecting panels. The reduction in radial post-tensioning also contributed to the panel cracking in contrast to the calculations performed at the time of construction.

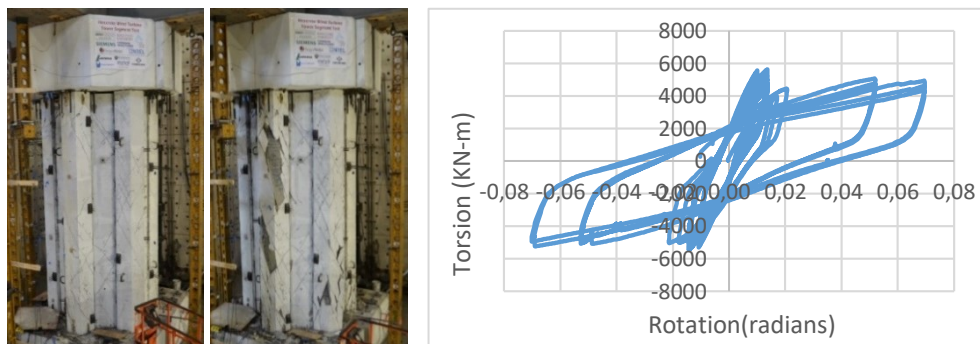
Figure 8: Large displacement damage (left) and response (right) of test unit

The test unit retained a large amount of load capacity after the decrease in stiffness, and therefore, torsional displacements were continuously applied in increasing magnitude beyond the extreme load envelope. Damage to the test unit progressed steadily as the torsional displacement increased beyond 0.017 radians (1 degree) of rotation (0.017 radians of rotation was five times the rotational displacement for extreme torsional loading). Both HSC and UHPC columns experienced torsional cracking, new cracks continued to appear on the HSC panels, and the epoxy between all of the column and panel connections began to crack or split vertically. The UHPC panels did not experience visible cracking, but gaps up to 6.35 mm (0.25 in.) opened between the UHPC panels and columns at the epoxy joint. At 0.07 radians (4 degrees) of rotation, spalling had occurred on both HSC and UHPC columns and the test was terminated due to damage to the foundation blocks. The progression of damage to the test unit during the large displacement cycles is shown in Figure 8 as well as the tower rotational displacement response. The test unit was still able to support the axial load simulating the weight of the nacelle and rotor after the completion of testing. The response of the test unit showed that the tower had sufficient ductility beyond extreme loads.
