INFLUENCE OF FIBRE CONTENT AND AGGREGATE SIZE ON THE BEHAVIOUR OF ULTRA-HIGH PERFORMANCE FIBRE REINFORCED CONCRETE DURING FIRE

Martin Schneider (1), Jerneja Kolšek (2) and Aljoša Šajna (2)

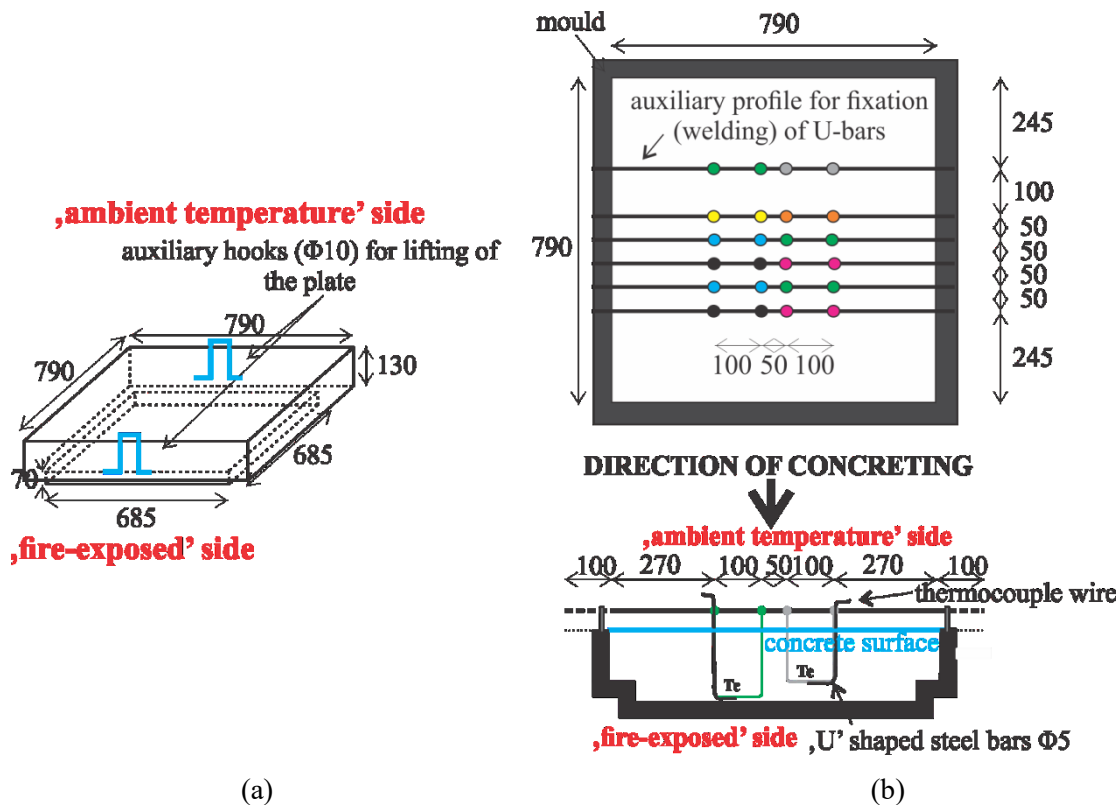
Figure 1: (a) Sketch of one plate (in mm). (b) Sketch of preparation of the plates. Coloured circles represent stiff fixations of the U-bars onto auxiliary profiles. The U-bars are represented by different colours which denote different depths of the bars, i.e. different positions of the hot junctions of the thermocouples with respect to the fire-exposed concrete surface: –25 mm (green), –40 mm (black), –55 mm (yellow), –60 mm (grey), –70 mm (blue), –85 mm (pink), –100 mm (orange).

Five plates were prepared from the designed 5 UHPFRC mixtures to be tested in a meso-scale fire experiment (Fig. 1-3). First, suitable moulds were designed in the way that each plate would fit exactly into a corresponding opening of the front cover of the fire-testing furnace (Fig. 3a). Before concreting, a special steel frame was also prepared for each mould using steel U-bars and auxiliary profiles which served for attachment and routing of thermocouples (Fig. 2-3). The frame was designed in a very high stiffness so that the sensors could remain in place during concreting despite high pressures of the low viscosity fresh concrete. K type Ni-Cr-Ni (2×0.5 mm) thermocouples with ceramic braided insulation were attached to U-bars.

More thermocouples were installed for measuring temperature at some concrete depths as demonstrated in Fig. 1 (e.g. for 25 mm depth three thermocouples were used at three different locations) but the corresponding time-temperature curves followed very closely to one another in most cases, thus, only one curve is shown for each depth. The exception is the curves for plate I measured at 25 mm depths where larger discrepancies were obtained due to intense spalling in this region. More temperature measurement stations were active for each depth of the plate but only one curve is shown as only small differences were observed between them. Otherwise, more curves with the same denotations are shown. Enclosed in brackets is the denotation of the plate.

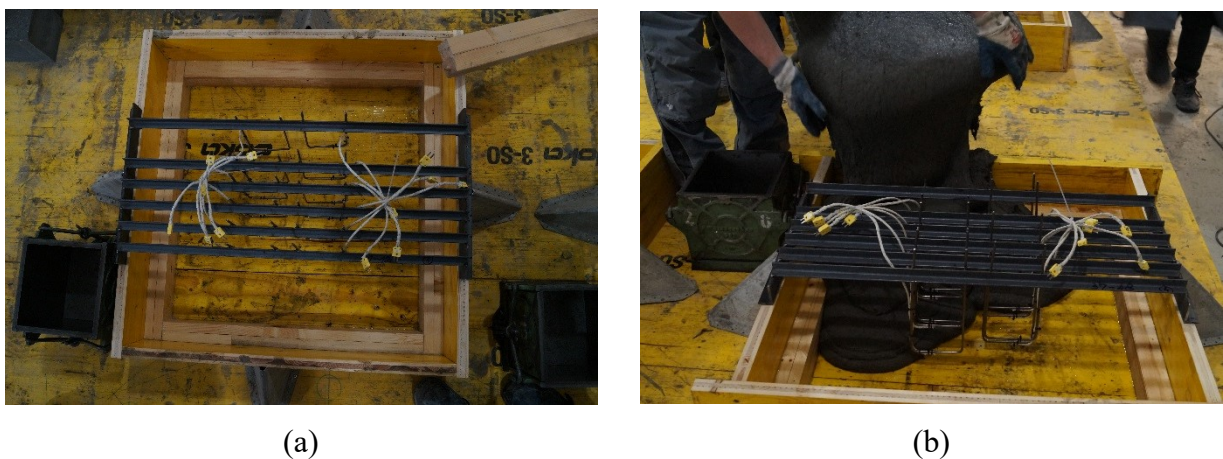
Figure 2: (a) The mould for preparation of one of the plates with attached auxiliary steel frame. (b) Concreting of the plate.

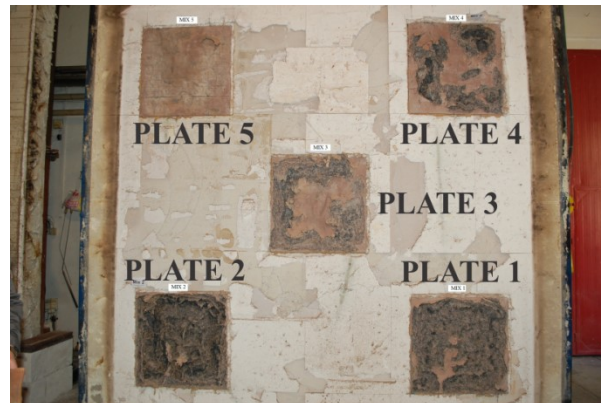
Fig. 4 shows the exposed side of the front cover of the furnace with 5 tested plates mounted. The photograph was taken after the termination of the test and 24-hours cool-down (note that no additional spalling was obtained during cool-down; the front cover of the furnace with the plates still embedded was cooled-down naturally, in the air). The extent of the spalled areas is clearly visible in Fig. 4a (see the grey areas visible on each plate except on the plate 5). In addition, there is some information regarding spalling depth in Table 5.

Figure 4: Exposed side of the front cover of the furnace after the fire test with visible spalling damage of the 5 plates.

Plate (Mix)	M1	M2	M3	M4	M5
Max spalling depth [mm]	51	99	42	56	7
