## Replacement of the Superstructure of the Nitelva Railway Bridge

### Summary

This paper presents the replacement of a one 100 years old railway steel bridge in two spans with two concrete post-tensioned box girder elements made of High Strength Lightweight Aggregate Concrete LC60. The removal of the old bridge and erection of the new one was done during two train stops of 24 hours in a very special way, which is described in more details.

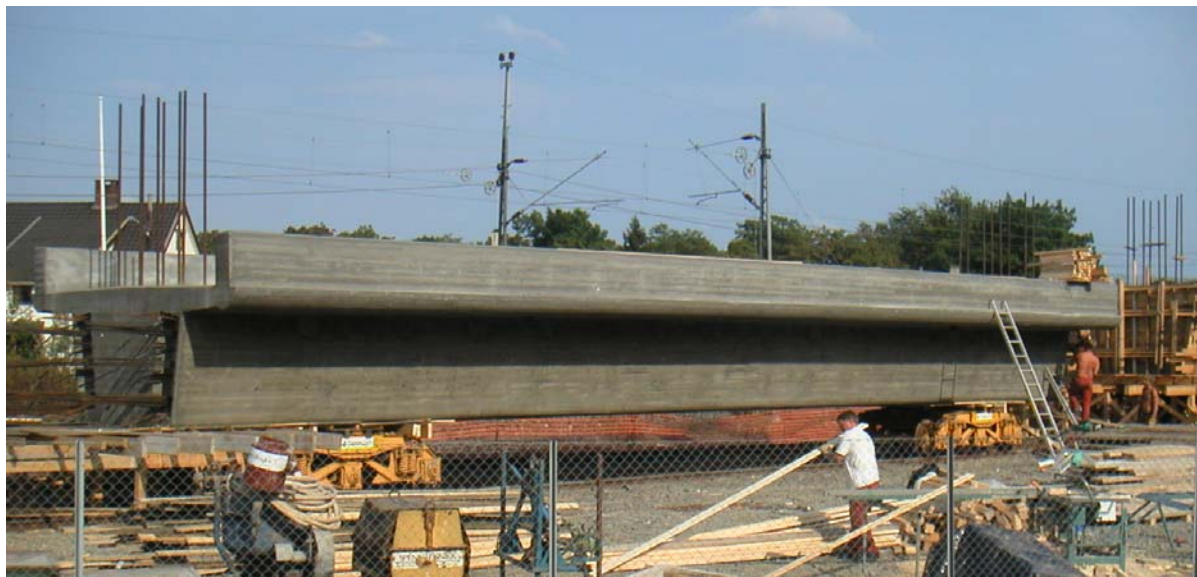
*Fig. 4 Element 1 ready for transport to site*

The elements were produced on bogies supported on the rails on a site close to the Lillestrøm station area, ca. 500 m from the bridge. Net weight was 150 tons for the shortest element ( $L=20\text{m}$ ) and 210 tons for the longest ( $L=28\text{m}$ ). In addition the new rails and most of the ballast were placed on top of the elements before transportation to the bridge site in order to save time during the very short installation period. This increased the weight of the elements to 290 tons for the biggest one and 180 tons for the smallest one see Fig. 4.

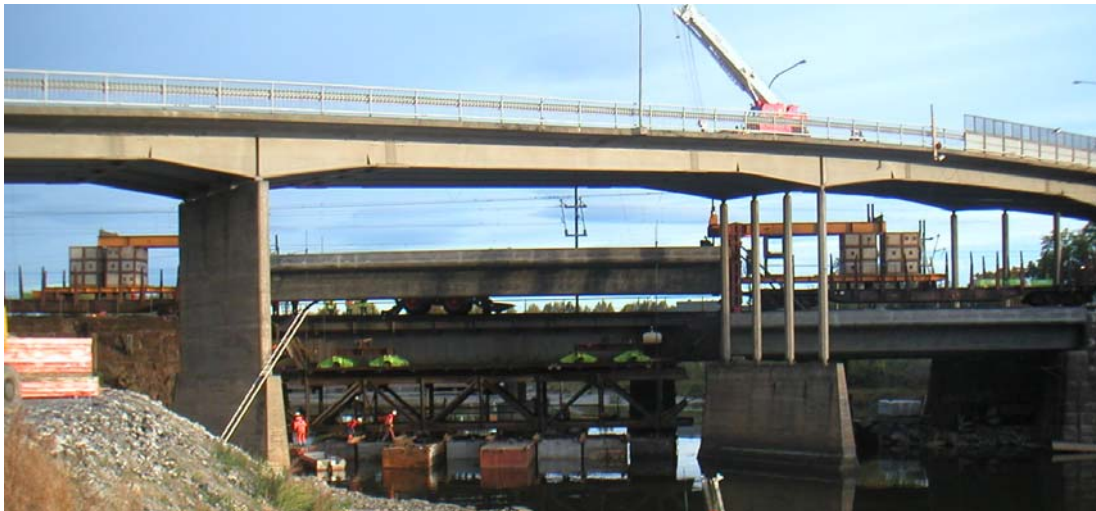
*Fig. 6 Element 1 in position, ready to be lowered, existing steel truss cut down and lowered on pontoons*

The steel truss is cut into 3 pieces and the central part is lowered down on a pontoon in the river below the truss. The two end parts are then cut down and lowered on the same pontoon, see Fig. 5c and Fig. 6.

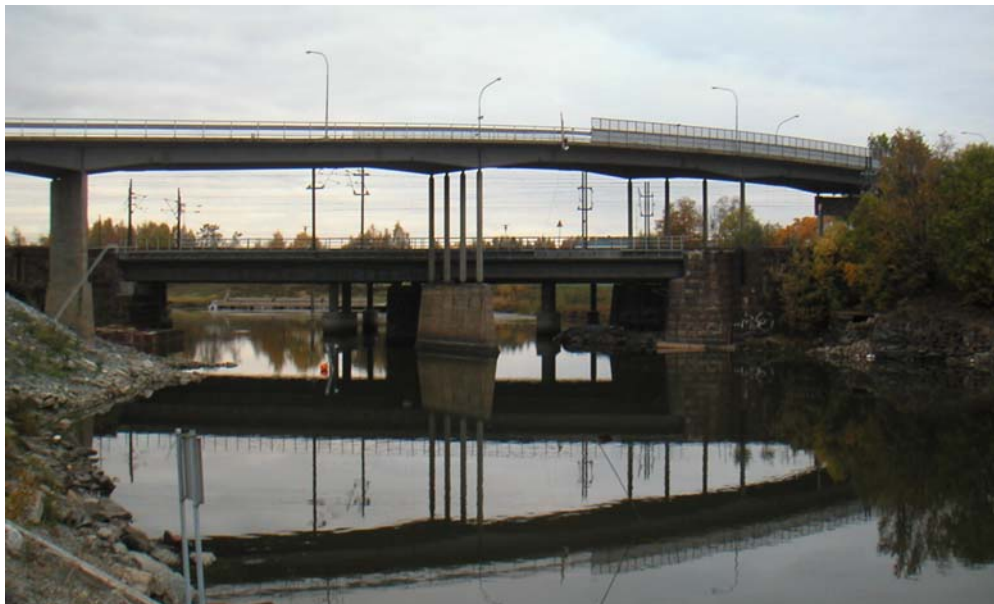
*Fig. 7 Completed bridge*

The Contractor Betonmast AS successfully performed the replacement work in two weekends, one weekend for each span, in September 2002, as shown in Fig. 7.
