## New Models for Old Buildings

**Péter LENKEI**  
Professor Emeritus  
Pécs University  
Pécs, Hungary

The possible factors influencing the changes of the mechanical models for structures in use are analyzed. Special attention is given to reuse of old buildings. Several practical case studies are presented. The necessary interventions and the consequences are discussed. It is concluded, that each case has some specific features, the interventions are further changing the structural model, and almost in all cases exist several different solutions.

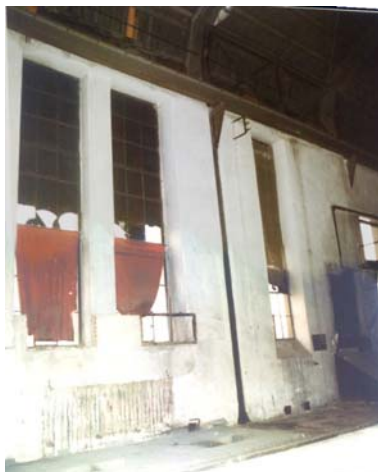
*Fig. 1a The view of the old shop interior*

Due to the termination of coal mining in the region of the City of Pécs, as it happened in plenty of places in Europe too, a bank-engine shop had to be converted into an warehouse of 11 m high clearance. The original lay-out of the shop (Fig. 1a) was ~18\*40 m in plan, the outside brick walls were ~650-800 mm thick.

On the ground floor were the machine foundations for the equipment, placed on 3 m elevation. The intermediate floor was supported by columns and machine foundation for the equipment over this floor. In addition this floor has openings, anchor places and masses for the equipment. The roof structure and the bridge crane are supported by a two hinged metal frame with bolted connection built in the walls and with steel ties built in the intermediate concrete floor.

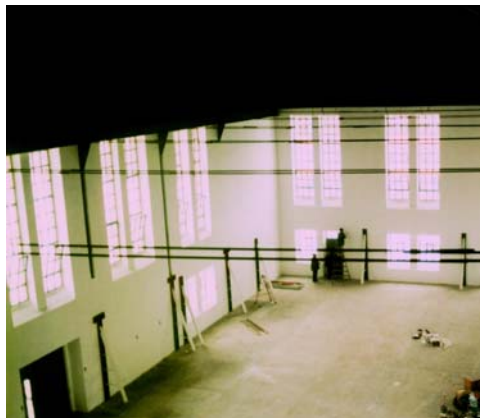
*Fig. 1b The view of the interior after alteration*

The building in its original form was not suitable for a 11 m high warehouse. The intermediate floor had to be removed, the ties were replaced over the bridge crane beams and the bridge crane was dismantled too (Fig. 1b). The horizontal connecting function of the intermediate floor was replaced by side supports.

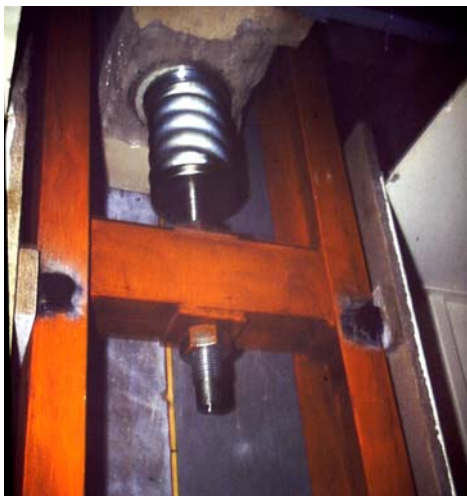
Fig. 3 The supporting spring

A heavy spring (Fig. 3) acting on the bottom of the reinforced concrete beam was installed on each small cross beam between the twin steel columns. The spring prestressing by a bolt was controlled not to have tension on the top surface of the concrete beam. This was illustrated by summing up the original bending moment diagram and the bending moment diagram from the springs' action, reducing the bending moment at the mid span considerably, but not changing its sign (Fig. 4).

The multistory building of a big consulting engineering office has reinforced concrete frames with 13 m span beams on the upper floors, forming large office rooms. Due to early removing of the formwork and bad quality of the concrete the beams gave large deflections. The contractor tried to correct this blunder by making an even bigger blunder, putting thick layers of concrete over the beam top at mid span and thick layers of plaster under the beam bottom near the columns, to level the deflections. As a consequence the load bearing capacity of the beams were exhausted, and due to moment redistribution in the beam-column joints intensive cracking was detected.

The intervention was a really radical upgrading, changing completely the mechanical model. The 13 m span was divided into two lines of smaller rooms with a corridor in between. On both sides of the middle corridor at each lateral frame two pair of steel columns supported by new foundations were placed.
