DIAGNOSIS AND RESTORATION OF FOUR EXCEPTIONAL EIFFEL-TYPE RAIL VIADUCTS

1. INTRODUCTION AND PROJECT BACKGROUND

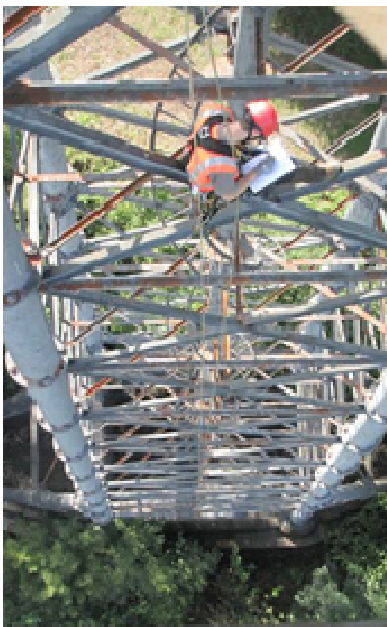
Figure 8: Additional dimensional measurements

- ⇒ *Brief visits carried out by means of rope access works (Fig. 6) and completed at night using hydraulic cradles (Fig. 7) designed to provide up to date information on all the defects which may affect the structures (elements coming apart, splitting, possible cracking, and so on), Taking additional dimensional measurements required for structural models and studies (Fig. 8),*

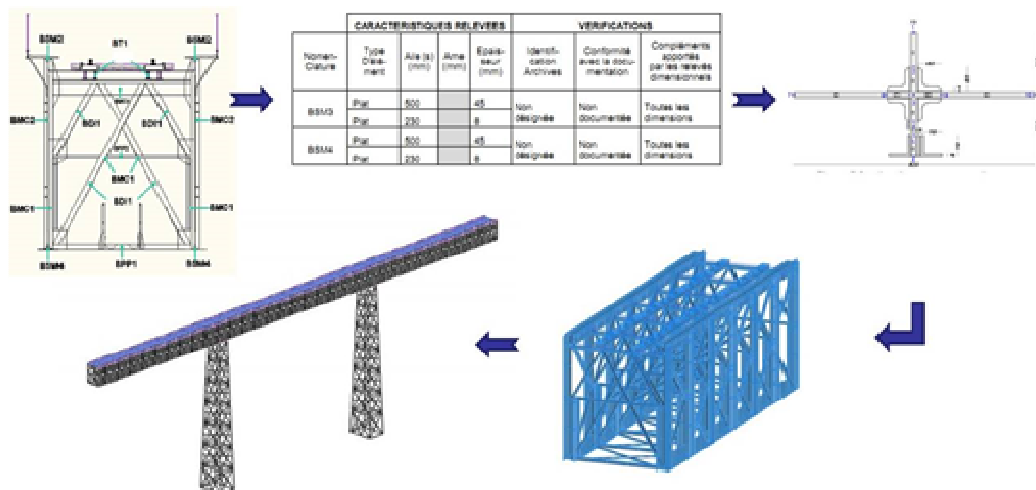
Figure 11: Structural analysis and modelling

These models were constructed from for reconstituting detailed geometry, and the results of samples taken in respect of the characteristics of puddled iron. In order to ensure the accuracy and reliability of the results of calculations that predicted the performance of these bridges, the models were based on the instrumentation and the load tests carried out during the diagnosis phase (Fig. 11).
